Willow-Leaf Analysis Determines Extent of Mine Contamination Plume on the Willow Creek Floodplain, Creede, Colorado

James A. Erdman, retired botanist, biogeochemist, Crestone, CO
Leigh Ann Vradenburg, Coordinator, Willow Creek Reclamation Committee, Creede, CO
Shea Clark Smith, Minerals Exploration & Environmental Geochemistry, Carson City, NV

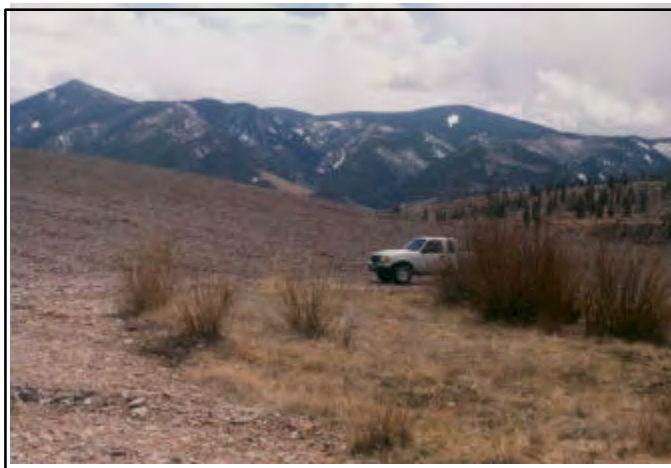
Willow sampling site #7- Note the gravel-capped tailings pile from the former Emperious Mill in the mid-distance.

On September 4, 2003, fourteen sites were sampled, with nine concentrated on the Willow Creek floodplain (Fig. 1). Five of those sampling sites were within about 30 meters of monitoring wells (MW). These included Site #1 at MW1, Site #5 at MW17, Site #6 at MW13, Site #7 at MW14, and Site #8 at MW3. Sites #6 and #7 occur at the base of the capped tailings. The willow-leaf sample from

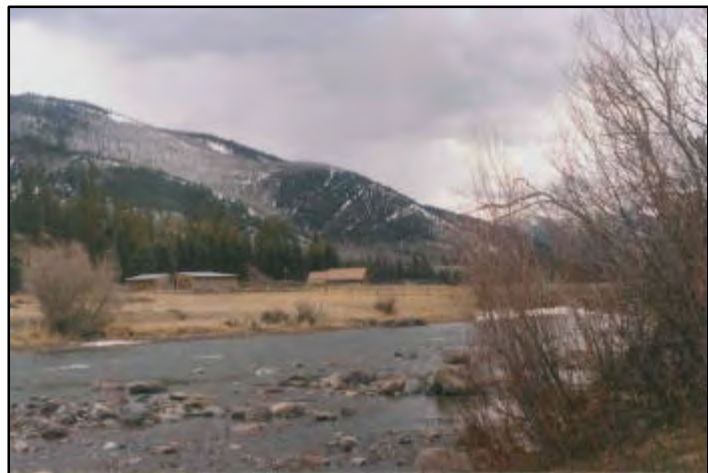
Willow sampling site #9- The willow cluster on the right □ lies on the edge of the Rio Grande, nearly a mile upriver □ from Willow Creek.
