Aquatic Resources Assessment of the Willow Creek Watershed

**Prepared by the
Ecosystems Protection Program
U.S. Environmental Protection Agency, Region 8
Denver, Colorado**

**for the
Willow Creek Reclamation Committee
Creede, Colorado**

August, 2005

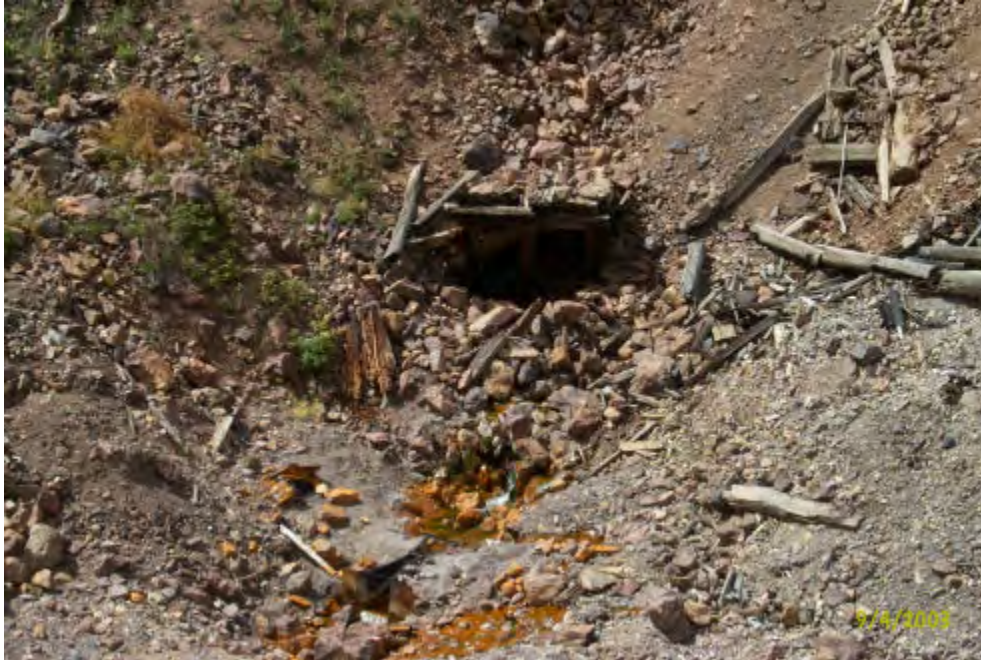
Figure 3.11 - Nelson Tunnel Adit

made up almost entirely of mine waste rock. The mine waste may act as a source of metals loading to the stream.

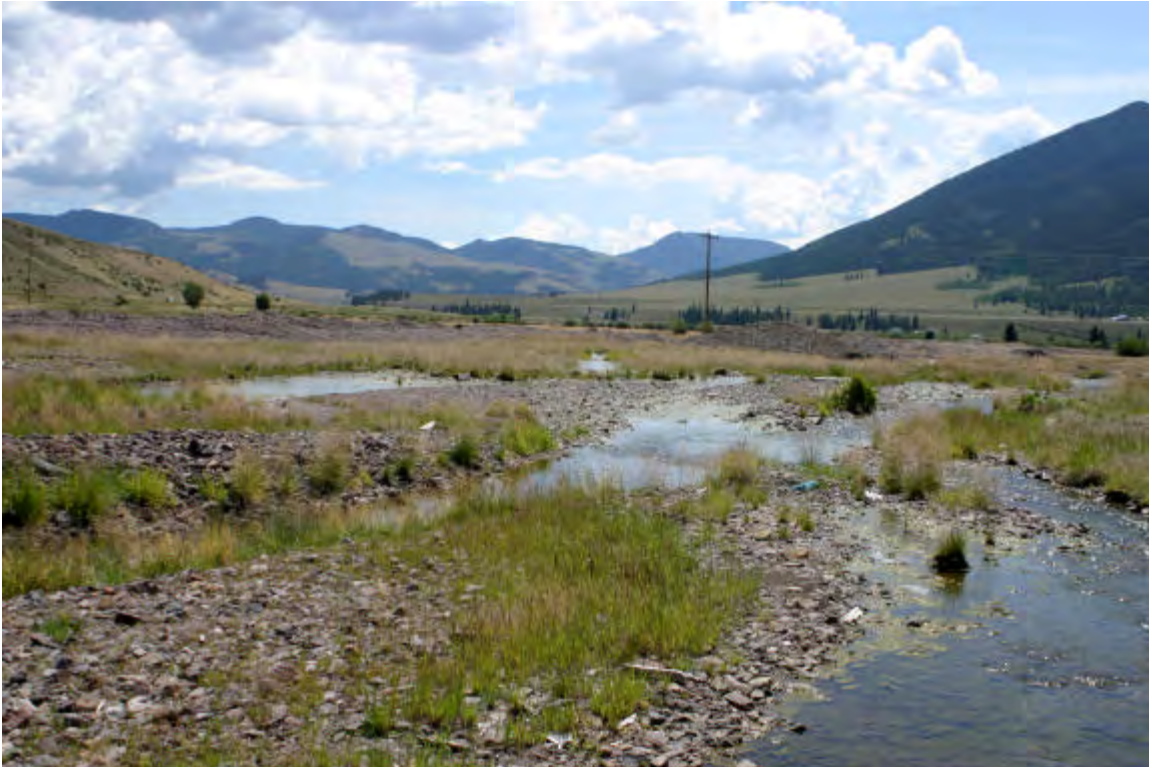
Figure 3.12 - Willow Creek Floodplain

USGS topographic maps of Creede at the 1:24,000 and 1:125,000, dated 1912 and 1914, respectively, show that the channel of Willow Creek below the City of Creede was not braided (USGS), historically. By 1959, a 1:62,500 USGS topographic map clearly shows braiding in the floodplain.

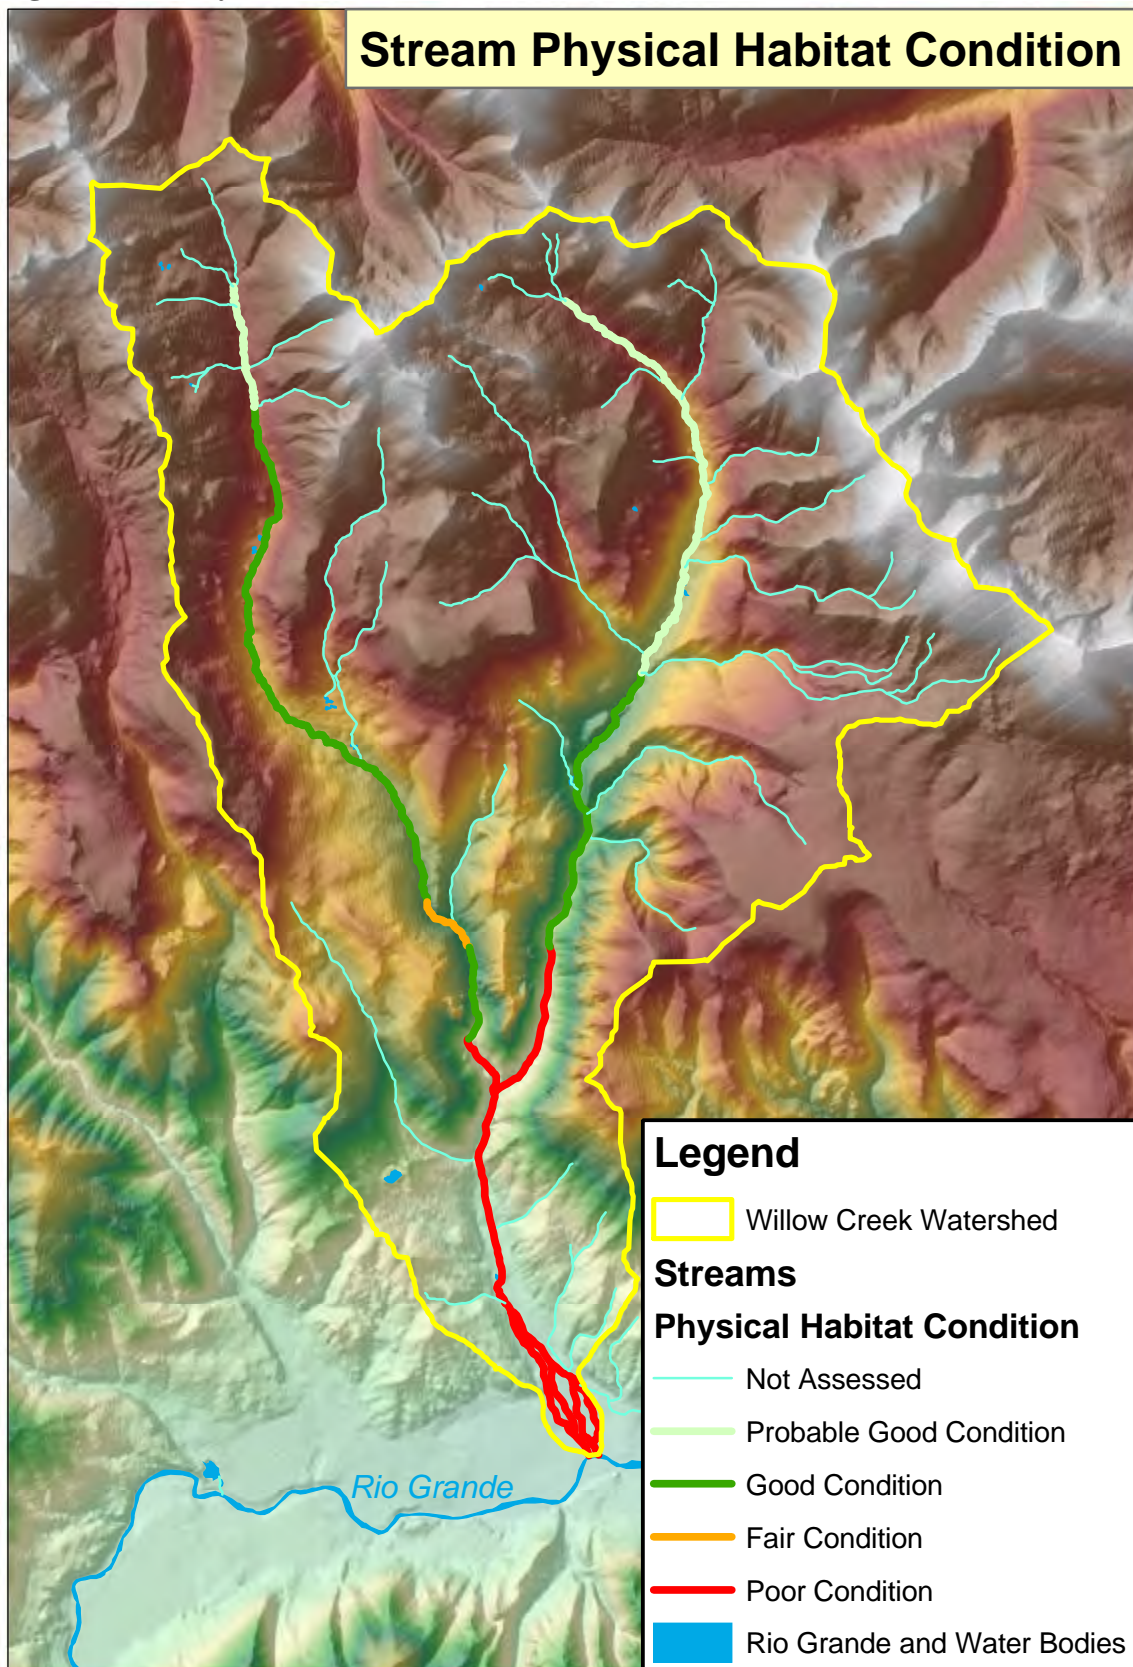
Figure 3.13 - Physical Habitat Condition of Streams in the Willow Creek Watershed

Figure 3.13 shows a classification of estimated overall physical habitat condition. Physical habitat condition classification is based on a composite of monitoring data for both in-stream and riparian habitat, and on the interpretation of aerial photography and GIS data layers covering the stream reaches. The condition classes of *good*, *fair*, and *poor* do not have a direct one-to-one relationship with the SRI/CSI classes in the in-stream section, although the SRI/CSI classes are an important component in determining the composite classification. **Appendix I** shows the USFWS's aquatic habitat assessment scores at monitoring sites for both RBP and SRI/SCI. This assessment's composite condition classification for stream reaches is also presented in the **Appendix I**. The USFWS monitoring sites are identified with the classified reaches.

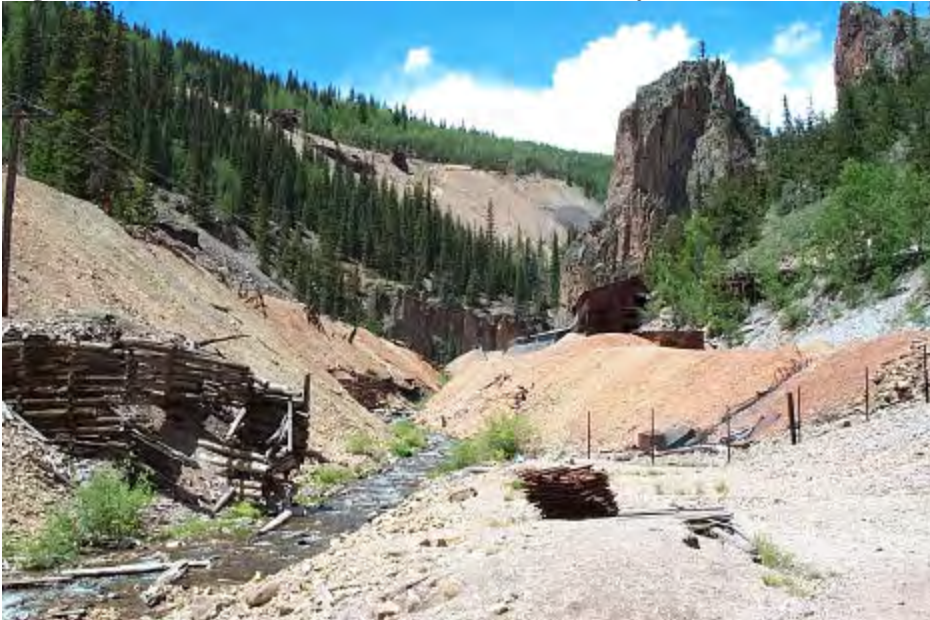
Figure 3.14 - West Willow Creek at the Amethyst Mine

Stressors on physical habitat condition include watershed disturbances and hydrologic modifications. The in-stream habitat in the Middle Section is significantly impaired by mine waste rock and mill tailings in steep topographic settings (Figure 3.14). This is especially noticeable on West Willow Creek. The flood control flume through Creede is a serious impairment to physical habitat condition (Figure 3.15), although it is very important for flood mitigation. The flume is a case where the same feature has opposite values depending on the value endpoint of physical habitat or hydrologic conditions. This assessment weights the flood control value of the flume more important than the physical habitat value of removing it. Grazing and forest clear-cutting are not current stressor issues in the watershed.

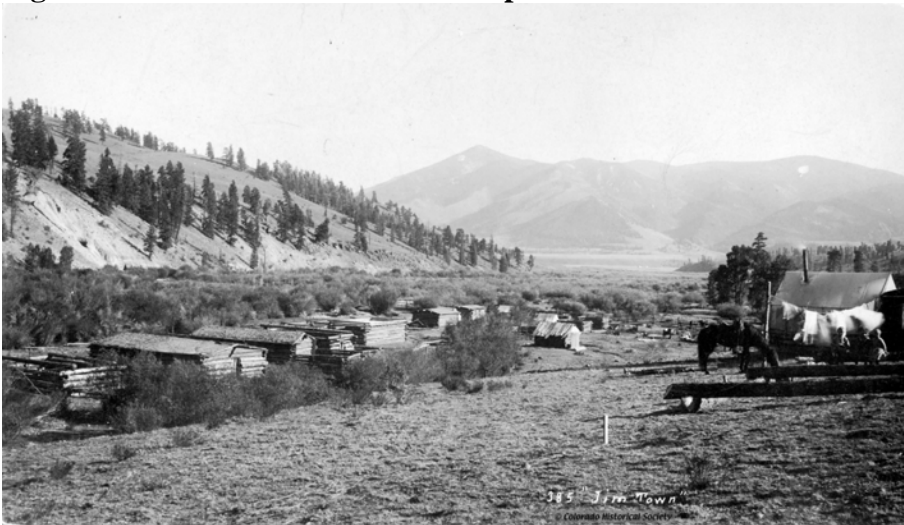
Figure 4.1 - The Willow Creek Floodplain in the late 1800s

Creede (Jimtown) / Willow Creek, Circa 1888-90 (Colorado Historical Society)

One of the goals of the WCRC is to restore the floodplain below Creede to help revegetation of the riparian area. To some degree, the historic condition of the floodplain prior to mining disturbances, as shown in old photographs, is a target reference condition (Figure 4.1). Another goal of the committee is to restore degraded sections of the creek within the mining district, including associated riparian areas and adjacent wetlands.

The Lower Section of the Watershed has more potential threats to wetland and riparian habitats than in the USFS owned lands. Obvious direct impacts to wetlands and riparian areas include filling and draining. The City of Creede and the land downstream of Creede are in private holdings. Significant historic impacts to the floodplain of Willow Creek exist below the current City of Creede. Mine tailings and outwash, including remnants of historic Creede during the mining boom, filled the floodplain in, and destroyed the natural riparian vegetation that existed in pre-mining days. Historic photographs below Creede show a dense willow carr type wetland in the valley bottom (Figure 4.1).

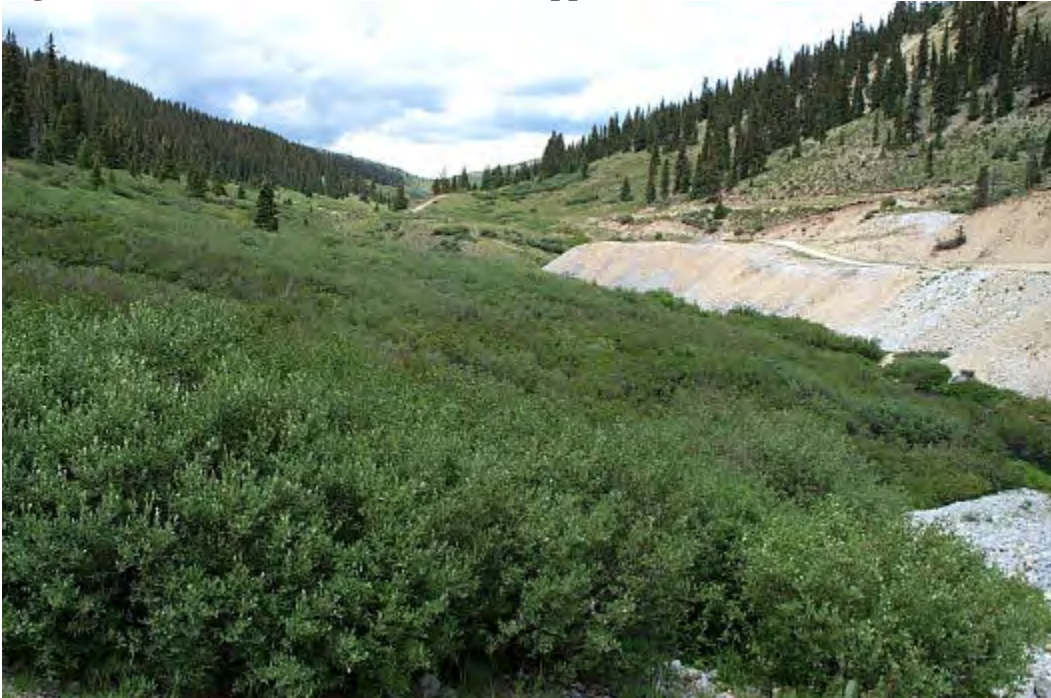
Figure 4.4 - West Willow Creek in the Upper Section

The Upper Section of West Willow Creek flows through a broad montane valley with abundant, relatively healthy slope-type and riverine-type wetlands adjacent to the active watercourse. Wetlands in this basin include low willow carr, wet meadows (marsh), and fen-type wetlands. Open water beaver ponds are scattered across the valley bottom providing high quality wildlife habitat for resident and migratory birds (Figure 4.3). Remediation of mining waste rock piles and tailings, including the roads built on them, provide excellent restoration opportunities for montane wetland mitigation projects (Figure 4.4).

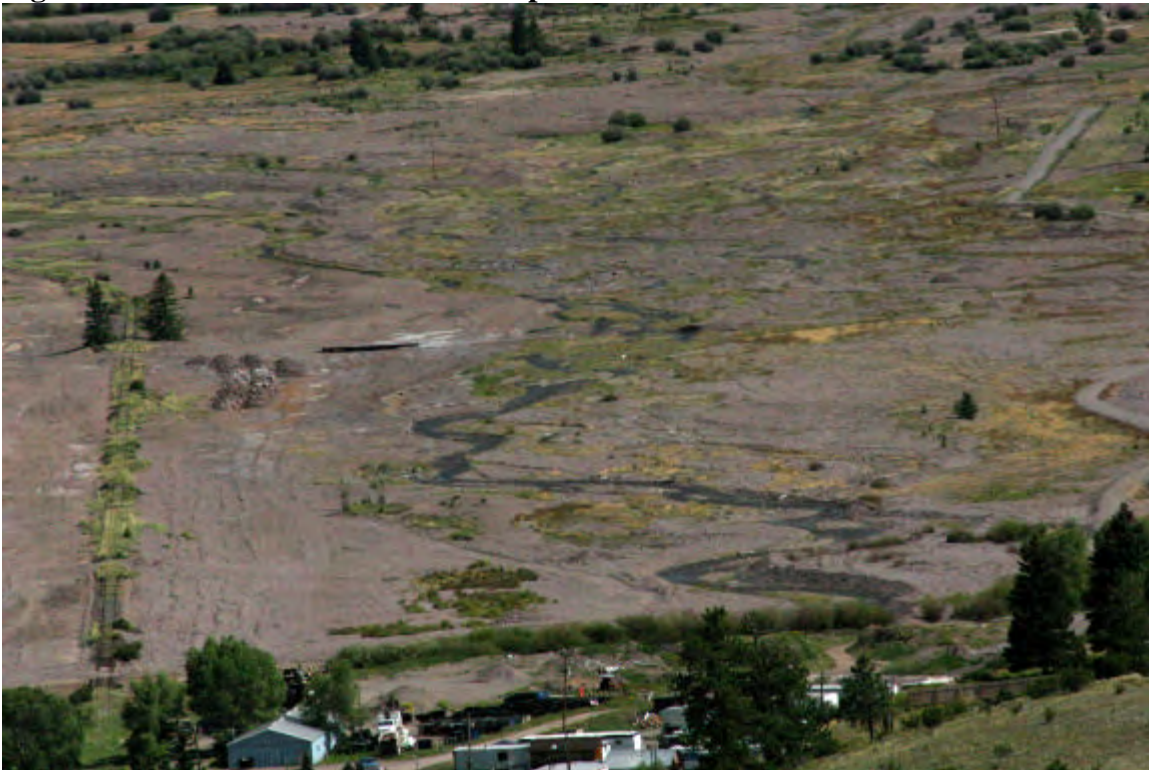
Figure 4.5 - Current View of the Floodplain

indicate impairment by excessive amounts of sediment in this area as previously mentioned in Chapter 3.4. Mining also resulted in the development of the mining boom City of Creede and other mining camps on the floodplain of Willow Creek (Figure 4.5). These adverse impacts occurred over several square miles, with the greatest impacts on the Lower Section directly below present-day Creede. Because of the historic impacts of sediment deposition and housing on the floodplain, there is a permanent lack of riparian vegetation, which severely reduces floodplain function. The floodplain south of Creede presents a stream restoration opportunity currently being developed by the WCRC and the U.S. Department of Agriculture's Natural Resources Conservation Service.
