**Regional Bankfull Characteristics for the Lower
Willow Creek Stream Restoration**

Job Number: Co0103B

Location: Creede, Colorado

Description of Job: Regional bankfull curve development for the Lower Willow Creek stream restoration.

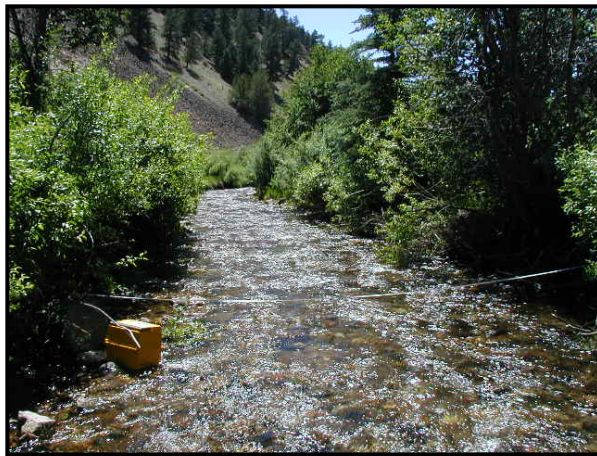
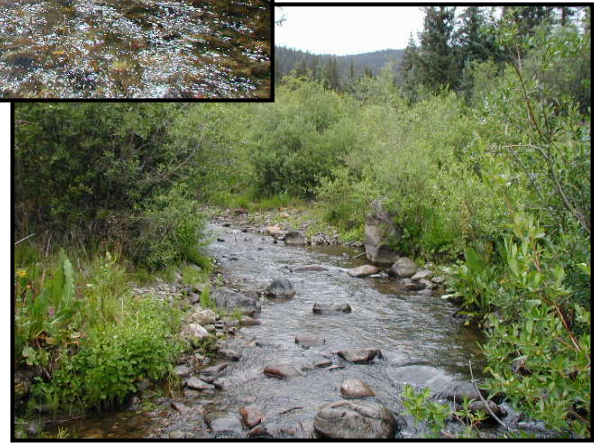
Miners Creek

West Willow Creek

Figure 4: Typical bankfull indicators. Specific indicators shown for West Willow Creek and Miners Creek.

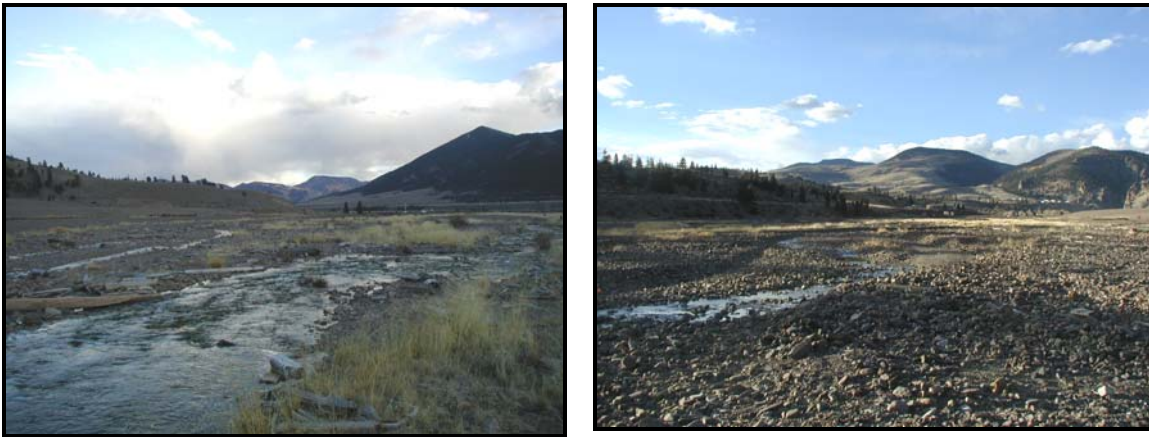
Figure 1: Current condition of Willow Creek downstream of Creede.

Willow Creek downstream of Creede is currently in a braided condition (Figure 1, 7 and aerial photo on report cover). This condition is atypical for streams in this region. There is a strong desire among the local community and in various agencies to restore the stream to a more typical sinuous condition, a physical condition that would better support aquatic life once water-quality improvements are made throughout the historically heavily mined watershed. The Natural Resources Conservation Service (NRCS) has taken on the task of designing the stream restoration project. In support of this design effort, a regional bankfull characteristics analysis was performed. This report documents the development and application of regional bankfull curves for application by NRCS designers, local officials, community members, and other interested parties.

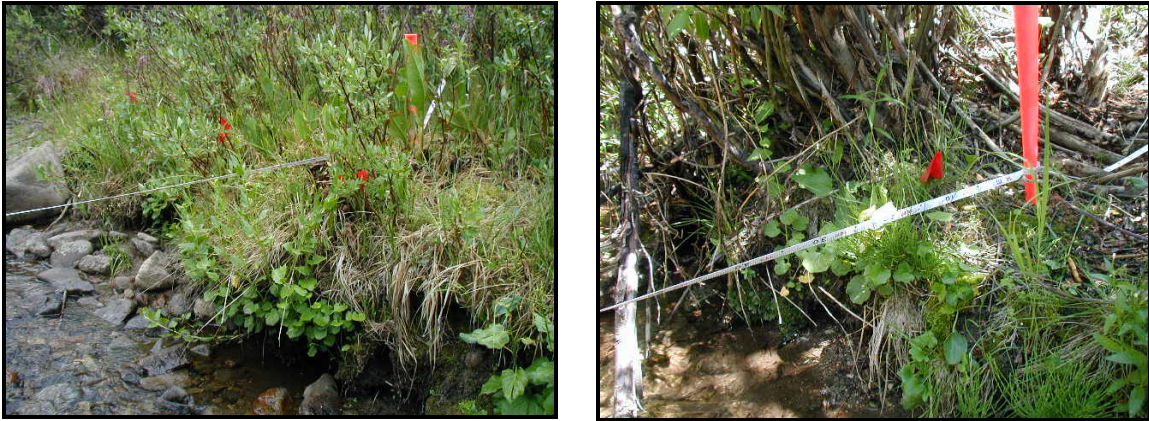
The field determination of bankfull stage is the important parameter to identify in this type of study. The procedure used to identify bankfull has been presented in Leopold 1994 and Rosgen 1996. Specifically, within a stream length of 10 to 20 bankfull widths, indicators were noted and flagged, assuring consistency within the reach. Low terraces were noted to prevent the misidentification of them as bankfull indicators. The bankfull indicators themselves included the presence of a floodplain at the elevation of incipient flooding; breaks in slopes of banks; change in particle size distribution; staining of rocks; exposed root hairs below an intact soil layer; and the location of lichens, alders, and willows (used with caution, especially considering the number of recent dry years). The flat depositional tops of floodplains and breaks in slopes were given precedence as indicators. Figure 4 provides a couple of bankfull indicator examples for specific reaches.

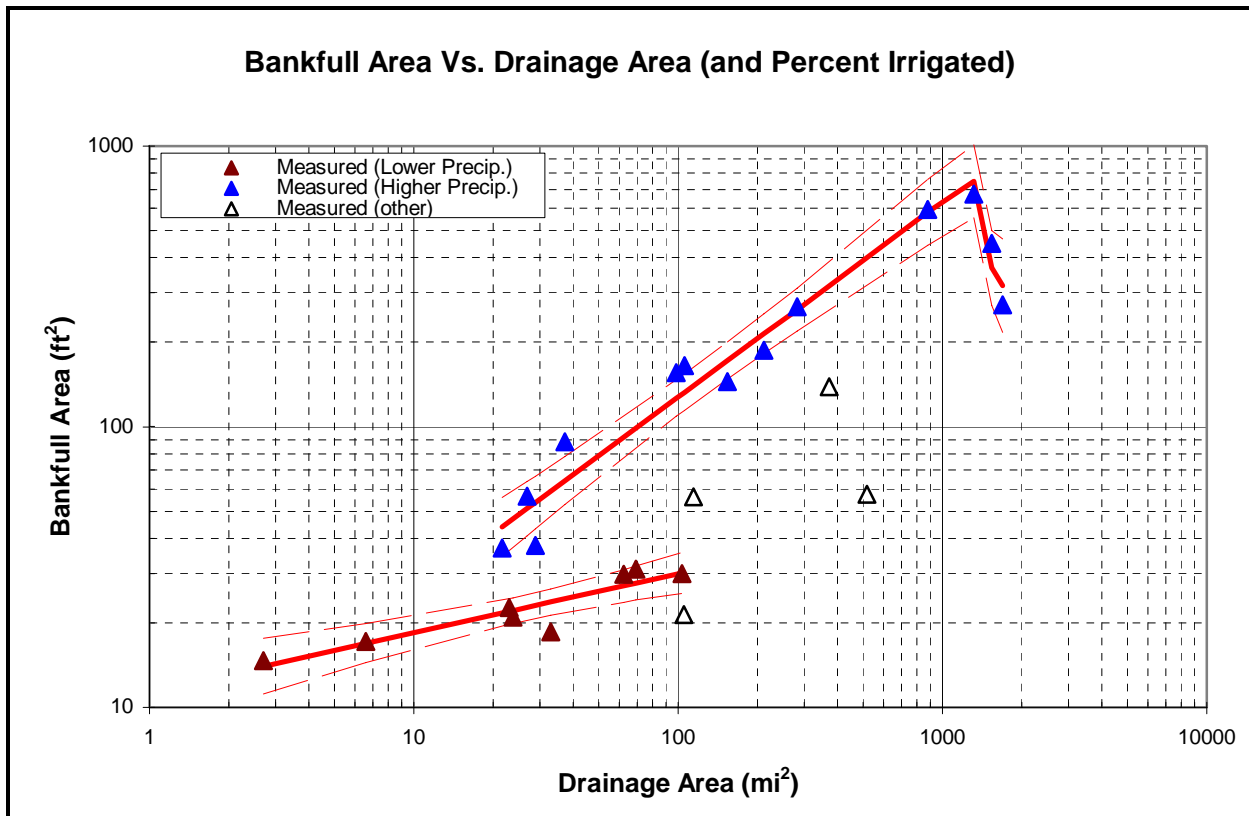
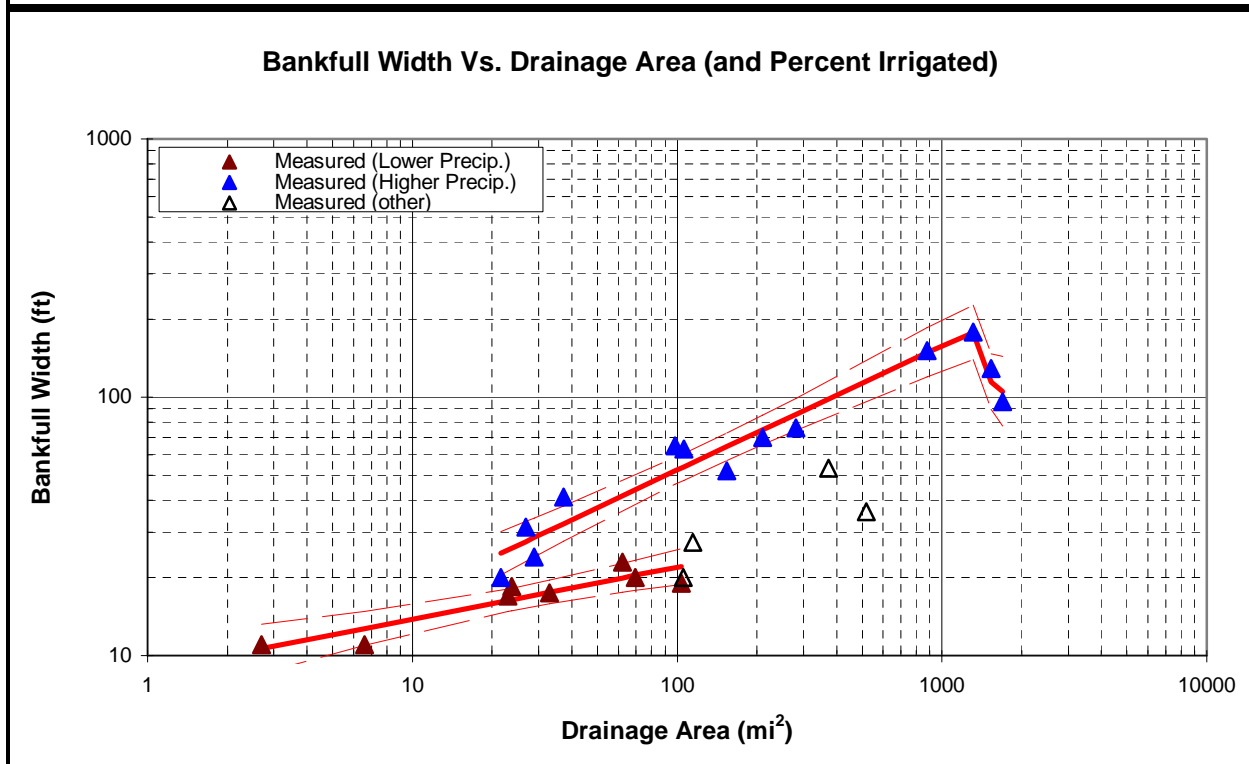
Figure 5: Bankfull area and width vs. drainage area and percent irrigated, with 95% confidence limits.

Results of this analysis are shown graphically in bankfull area versus drainage area (and percent irrigated) and bankfull width versus drainage area (and percent irrigated) of Figure 5.

$$A_B = 11.39(1.622)^{\log(A_D)} \quad (1)$$

where A_B is bankfull area and A_D is drainage area in square miles. This simple linear regression model has an associated R^2 of 0.84 and an F-statistic of 32.2. Eight sites were used to generate the prediction. Drainage areas ranged from 2.7 to 103.5 square miles.

$$W_B = 8.706(1.591)^{\log(A_D)} \quad (2)$$

where W_B is bankfull width and A_D is drainage area in square miles. This simple linear regression has an associated R^2 of 0.84 and an F-statistic of 31.8.

$$A_B = 5.174(4.969)^{\log(A_D)}(0.9634)^{I_P} \quad (3)$$

where A_B is bankfull area, A_D is drainage area in square miles, and I_P is percent irrigated area. Importantly, percent irrigated represents the total irrigated area diverted from the stream above the point of interest (not just the irrigated area within the watershed) as a ratio to total contributing drainage area. This multiple linear regression model has an associated R^2 of 0.96 and an F-statistic of 109.6. Thirteen sites were used to generate the

$$W_B = 5.653(3.040)^{\log(A_D)}(0.9768)^{I_P} \quad (4)$$

where W_B is bankfull width an A_D is drainage area in square miles, and I_P is percent irrigated area. This multiple linear regression has an associated R^2 of 0.94 and an F-statistic of 83.1.

A limited number of data points were used to generate these bankfull area and width relationships. Thirteen data points were used in the higher precipitation regime and eight data points were used in the lower regime. Five data points were also found to not fit either of the curves – they appear to fall into different and undefined climate zones. More data could better define these relationships or illuminate other relationships. Due to the possible specification of unknown climate zones within this region, application of these equations must be done with care. With respect to Lower Willow Creek, the lower curve is considered applicable since several of the sites are immediately adjacent to or within the Willow Creek watershed.

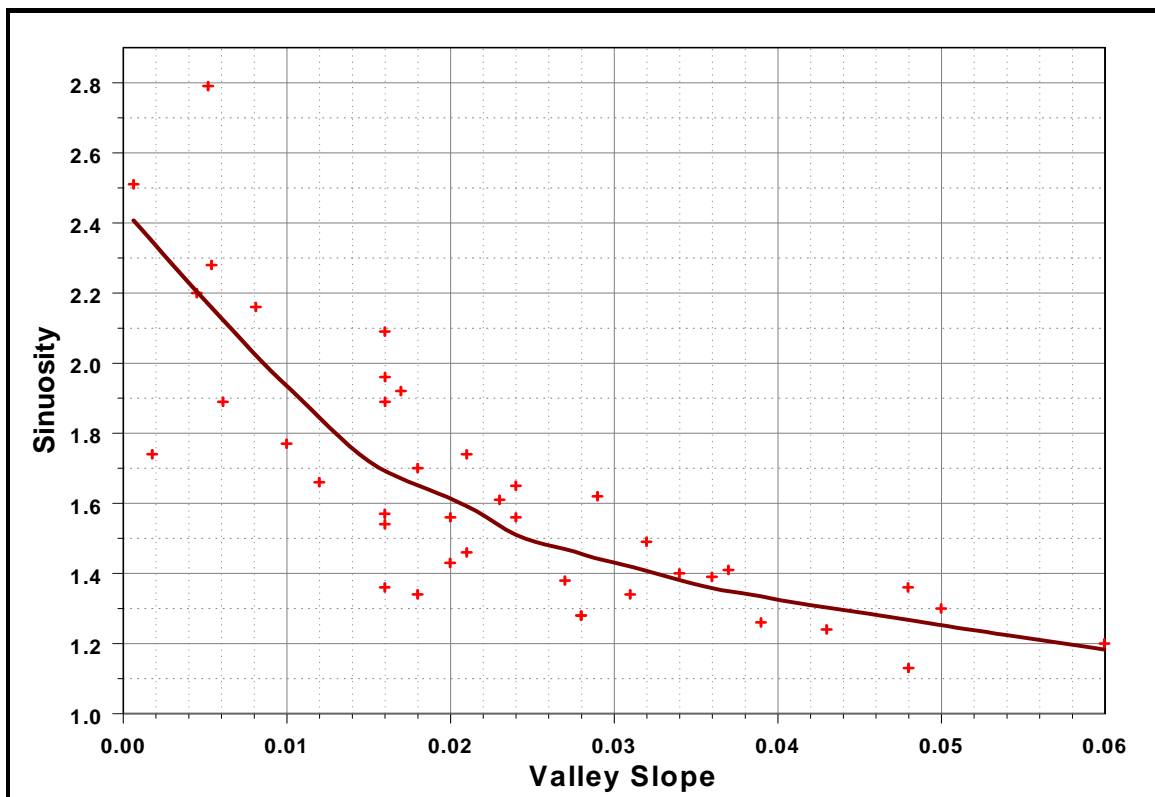
Figure 6: Sinuosity versus valley slope in the Upper Rio Grande watershed, with a Loess Curve (a locally-weighted linear regression).

To allow prediction of an average sinuosity for Lower Willow Creek, sinuosity and valley slope was measured for 40 sites within the upper Rio Grande watershed and plotted. Sinuosity ranged from 1.13 to 2.79 while valley slope ranged from 0.060 to 0.00065 ft/ft. The sinuosity and valley slope data are provided in Figure 6 and Appendix B. Locations of sinuosity measurements have been provided in Figure 3.

Though a trend is evident, scatter in these data are also evident – in addition to measurement error, other variables beyond valley slope appear to influence sinuosity. Such variables may include bed material size, climate, and vegetation prevalence.

A local regression (loess) curve has been provided in the sinuosity versus valley slope plot. Loess is a generalization of running means, with individual curve points being weighted in a linear regression by its distance from the point of interest. Connecting the points creates the smooth curve. Use of the curve enables the prediction of an average sinuosity for specific valley slopes in the Upper Rio Grande watershed.

An average sinuosity for the Lower Willow Creek was predicted through the use of Figure 6, using the valley slope for the reach (0.022 ft/ft). For consistency with how the figure was created, valley slope was computed from USGS topography. Results are provided in Table 1.

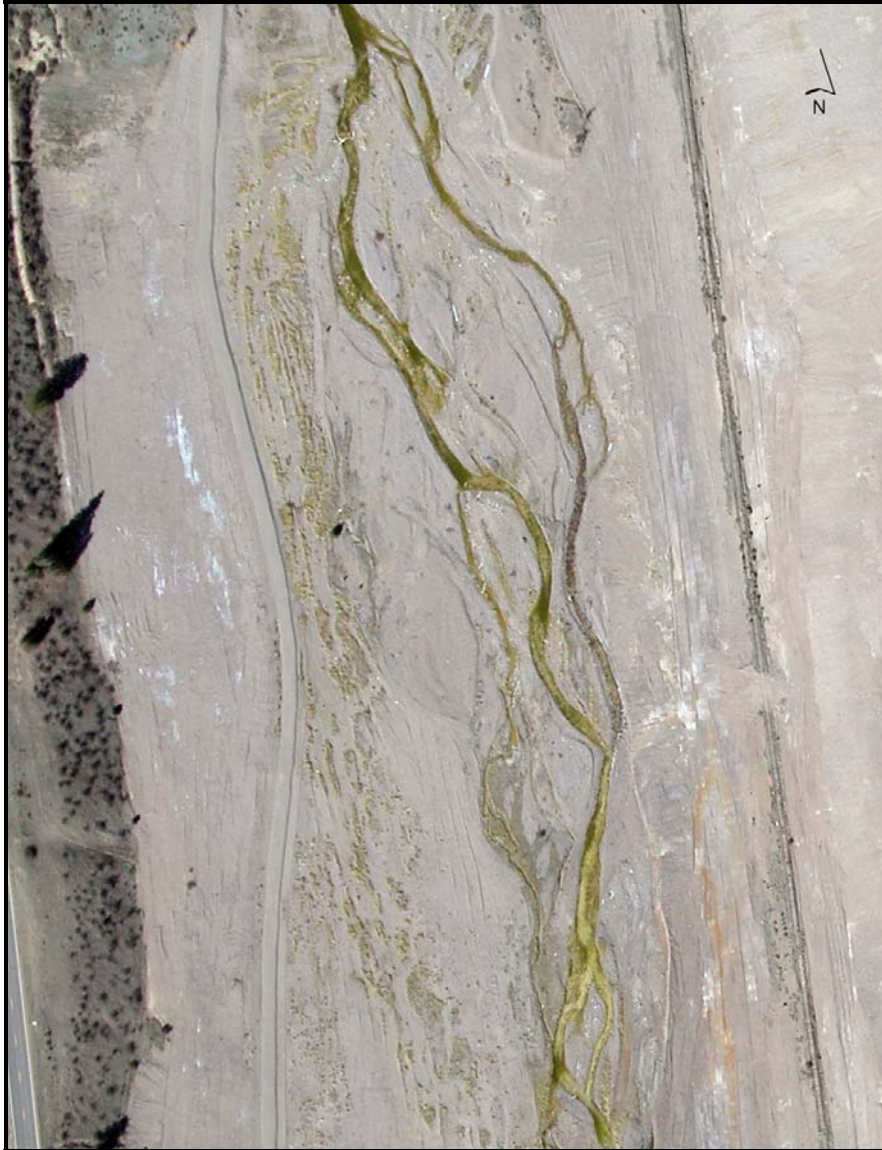
Figure 7: Willow Creek braiding. Photo courtesy of Kelley Thompson and Agro Engineers.

Figure 7 provides an aerial photograph of Lower Willow Creek, just downstream of the flume. The braiding and channel instability is blatant. Note the sparse vegetation on the floodplain.
